IA-32 Intel® Architecture Software Developer's Manual

Documentation Changes

December 2002

Document Number: 252046

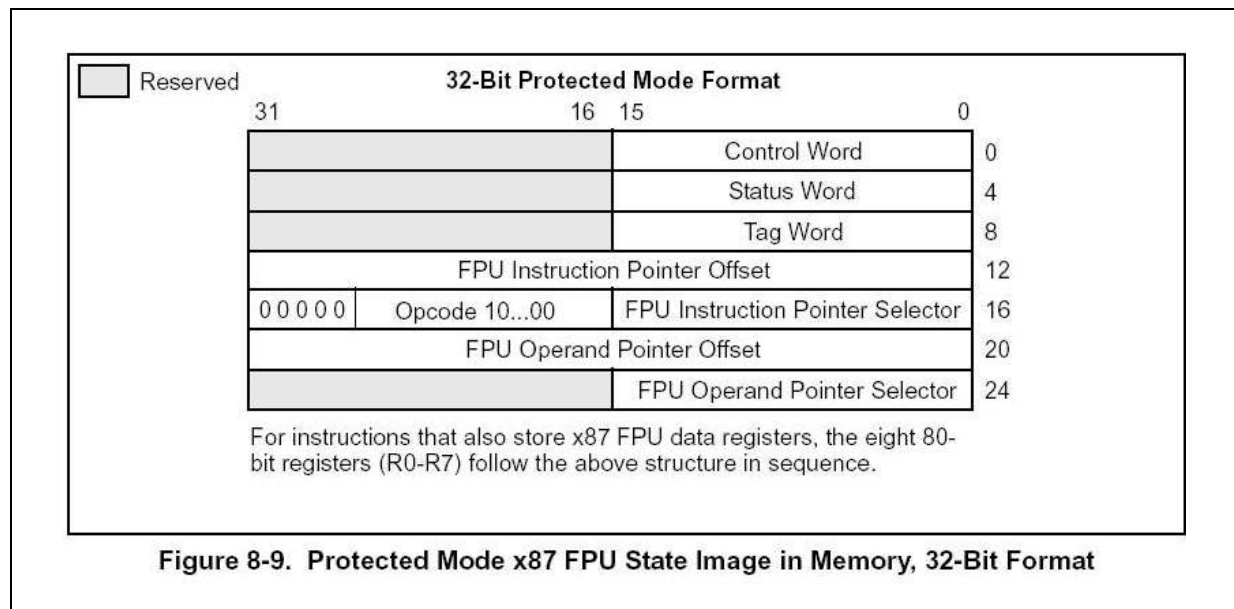
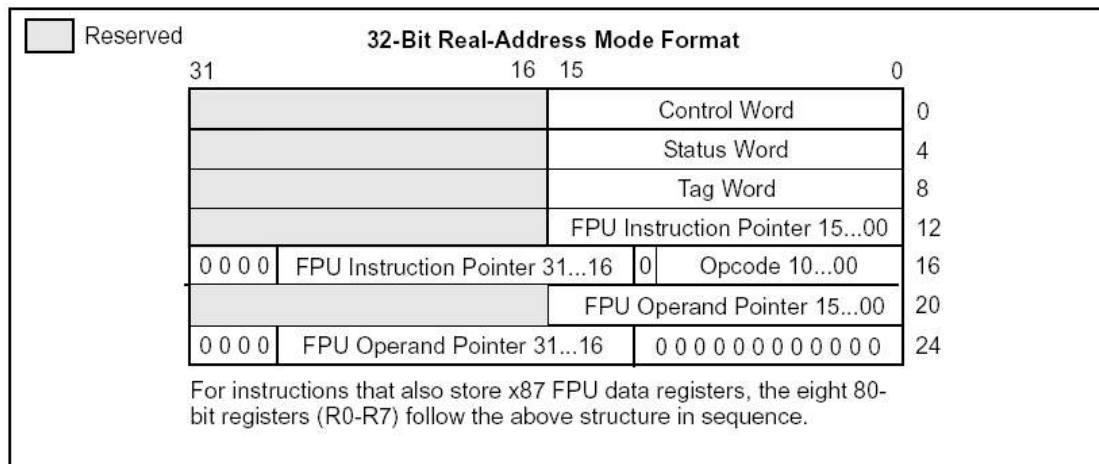
Figure 8-10. Real Mode x87 FPU State Image in Memory, 32-Bit Format

9. Specified for FSAVE
